# Intravesical penile implant reservoir: case report, literature review, and strategies for prevention

BB Garber<sup>1</sup> and A Morris<sup>2</sup>

*International Journal of Impotence Research* (2012) **25**, 41–44; doi:10.1038/ijir.2012.31; published online 30 August 2012

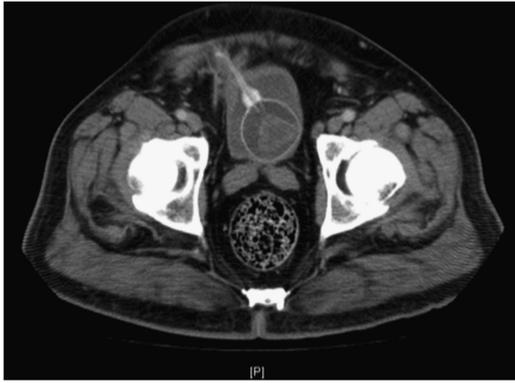
The patient was emergently admitted to the hospital, and placed on parenteral antibiotics. A CT scan was performed to document the position of the reservoir and facilitate its removal. This study revealed that the IPP reservoir was completely within the urinary bladder (Figure 1). After medical optimization, he was taken to surgery to rectify this Clavien Grade IIIb surgical complication. Cystoscopy revealed no sign of cylinder erosion into the urethra, but the IPP reservoir was fully within the urinary bladder, as seen on the CT scan. The cylinder–pump combination was explanted via the scrotal incision; the intravesical reservoir was removed via midline laparotomy, cystostomy and cystorraphy. All infected areas were lavaged with antibiotic irrigation (rifampin and gentamicin, 1 mg of each per ml.) Drainage was accomplished via an 18-French suprapubic cystostomy tube, a 20-French urethral catheter, a scrotal Penrose drain and a flat closed-suction drain in the pre-vesical space. The patient was given a 10-day course of antibiotics, as directed by wound cultures from the infected IPP, and was discharged 3 days postoperatively. Cystography several weeks postoperatively documented bladder integrity, and all catheters and drains were subsequently removed.

**Figure 1.** Non-contrast axial CT scan reveals AMS reservoir located completely within the urinary bladder; inflammatory reaction is seen in peri-vesical space at site of erosion.

As seen in the present case report, gradual intravesical reservoir erosion may occur because of peri-prosthetic infection that is allowed to linger. If an infection is allowed to smolder and is not treated surgically, this will predispose to erosion of the reservoir into the bladder, erosion of the cylinders into the urethra and/or erosion of the pump through the skin. In patients with peri-prosthetic infection, the way to avoid this scenario is via prompt explantation and/or salvage procedure. Wilson<sup>14</sup>

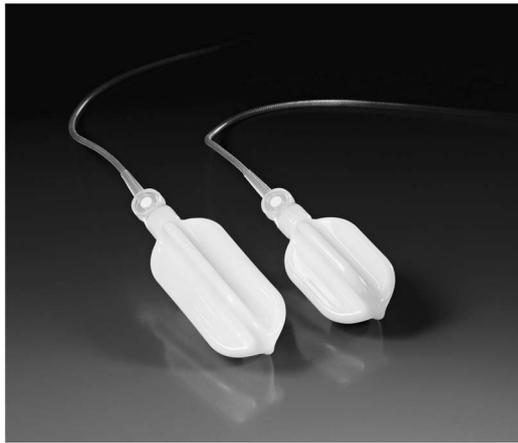
**Figure 2.** Titan CL Cloverleaf reservoirs in 75 and 125 cm<sup>3</sup> sizes. Courtesy of Coloplast. [www.us.coloplast.com](http://www.us.coloplast.com)

In summary, there are too few reported cases, and no randomized controlled trials, to allow us to make unequivocal recommendations on any of the above topics. In an attempt to improve their reservoir configuration, Coloplast has recently transitioned to a Titan CL Cloverleaf reservoir (Figure 2). American Medical Systems has recently introduced a flattened Conceal reservoir in addition to its standard round reservoir (Figure 3). It is unclear whether these new reservoir configurations will decrease the rate of reservoir-related complications. However, adherence to the aforementioned surgical principles may decrease the likelihood of a bladder-related reservoir complication.

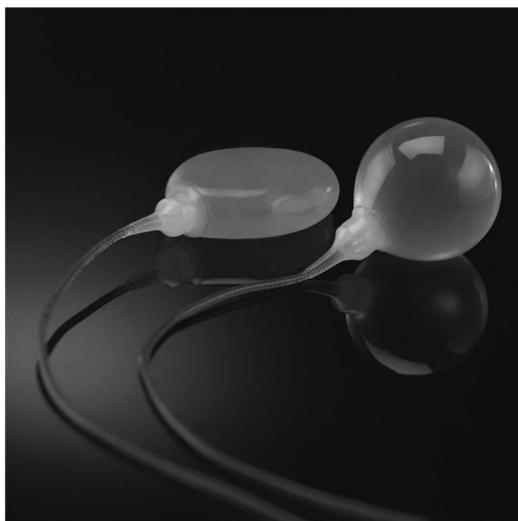
**Figure 3.** AMS regular and flattened Conceal reservoirs. Courtesy of American Medical Systems. [www.americanmedicalsistemas.com](http://www.americanmedicalsistemas.com)
